Regarding: Diode for horn, X1	PUP No.:	25-004
	Prepared by:	LPA
	Date:	15-04-2025
	Internal <input checked="" type="checkbox"/>	External <input checked="" type="checkbox"/>

Diode for horn - X1

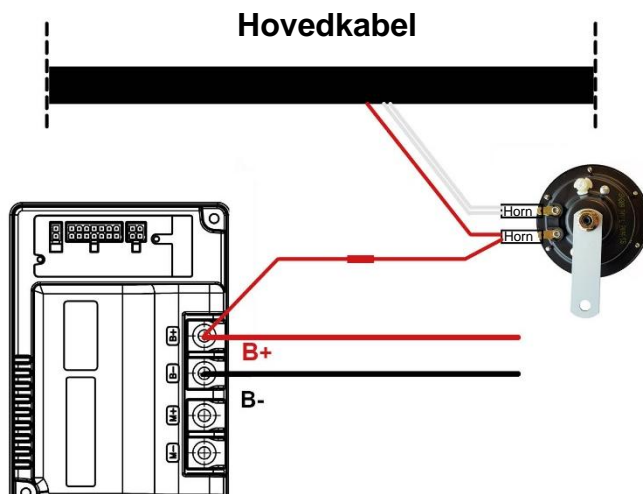
Derfor har vi flyttet diodens placering, så den nu har forbindelse til B+

Fra Serienummer 03-57970-25-02 er en diode 1505-1572 Diode for horn, monteret som på billedet nedenfor.

I tilfælde af at dioden skal eftermonteres, skal den tidligere diode afmonteres.

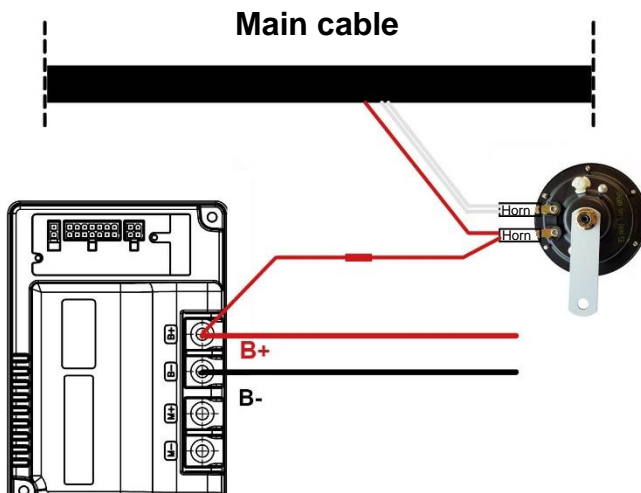
Therefore, we have moved the diode's location so that it is now connected to B+

From Serial Number 03-57970-25-02 is a diode 1505-1572 Diode for horn, mounted as in the picture below.

In case the diode needs to be retrofitted, the previous diode must be removed.

See attached assembly instructions.

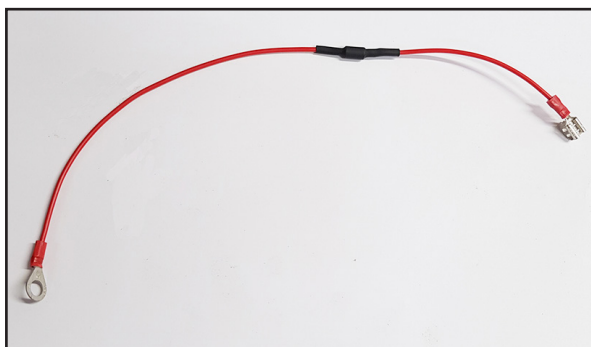
Denne diode er monteret fra fabrikken fra serienummer 03-57970-25-02.

Når diode for horn monteres på X1 forhindrer det, at Mini Crosser X1 påvirkes på ovenstående måder.

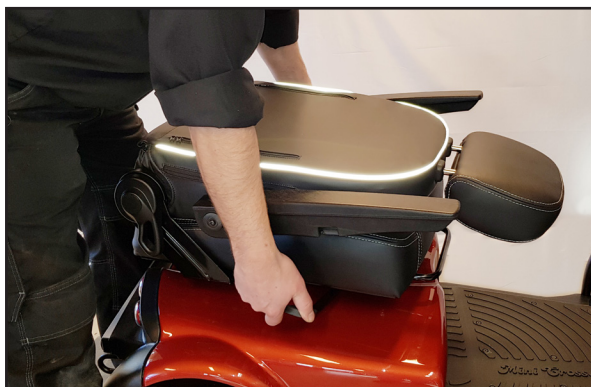
Afmontér sædet. Udløs sædedrej - drej sædet lidt og løft det af. Pas på ryggen.

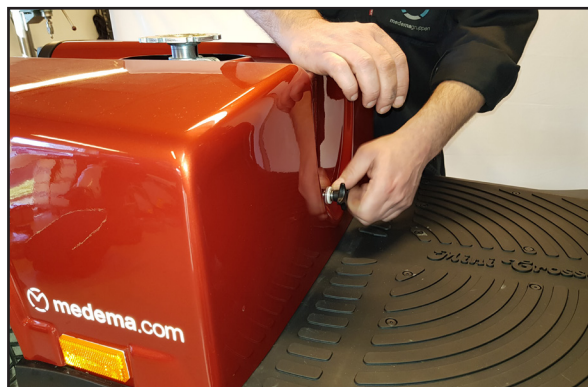
Afmontér batterikåben. Afmontér fingerskruen og træk batterikåben af.

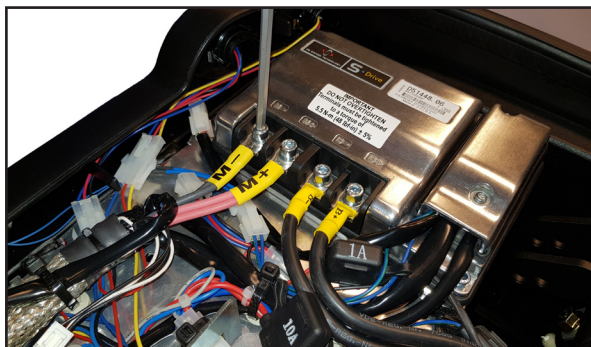
Elektronikplade for X1

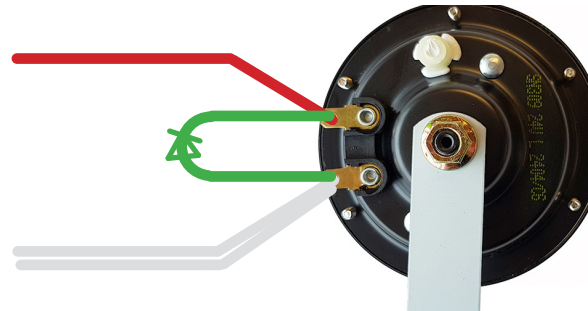
Fra Serienummer 03-52797-22-06 blev en diode monteret som vist ovenfor. Den skal afmonteres før den nuværende diode monteres.

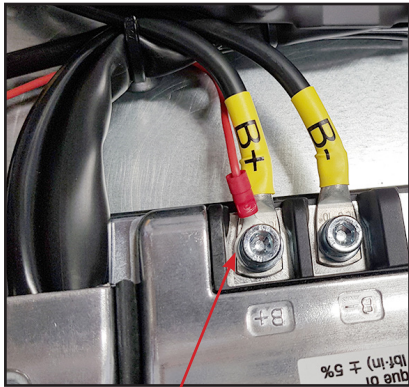
Ny diode - kabelskoen på diode-sættet monteres sammen med B+.

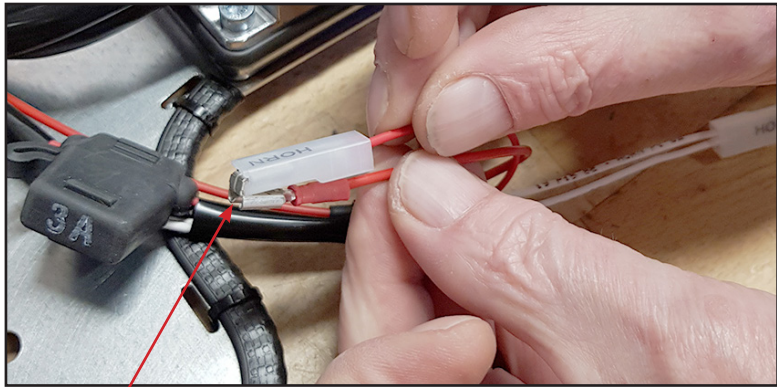
Stikket i den anden ende monteres på det røde Horn kabel. Klipses i som vist.

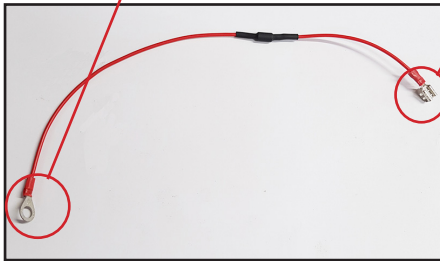
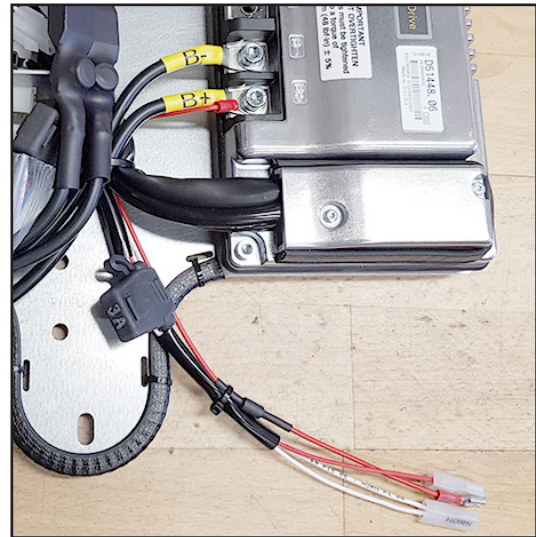
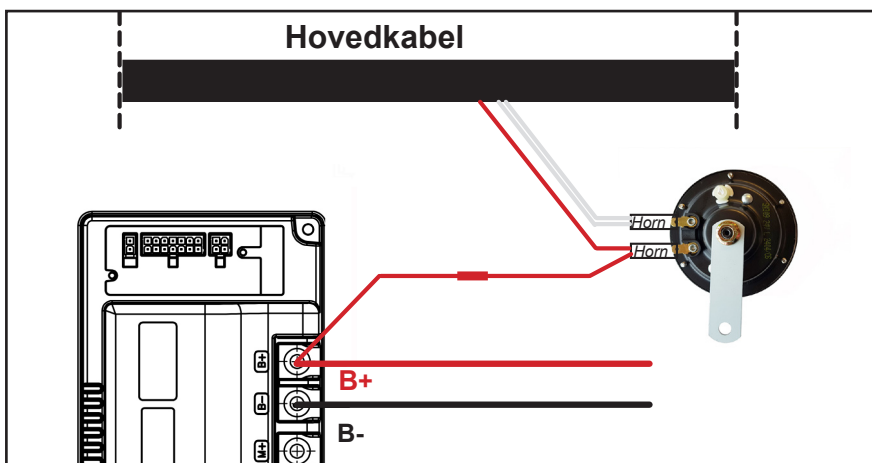
Diode for horn - X1 monteret.

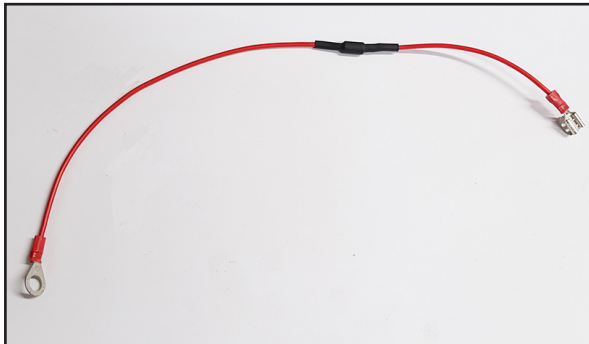
Diode for horn - X1

This diode is factory installed from serial number 03-57970-25-02.

When the diode for the horn is mounted on the X1, it prevents the Mini Crosser X1 from being affected in the above ways.

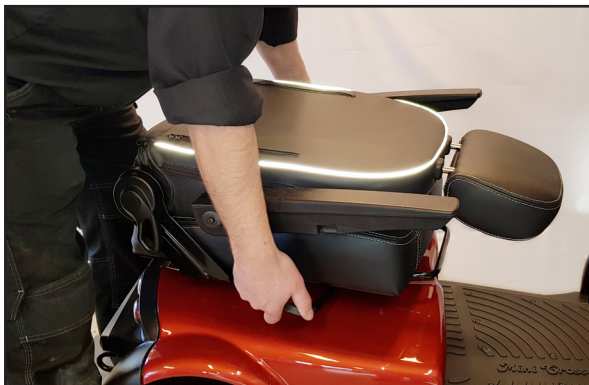
Remove the seat. Release the seat swivel - turn the seat slightly and lift it off. Be careful of your back.

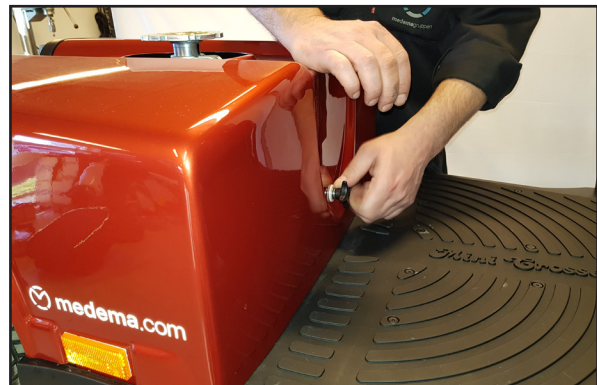
Remove the battery cover. Remove the thumbscrew and pull off the battery cover.

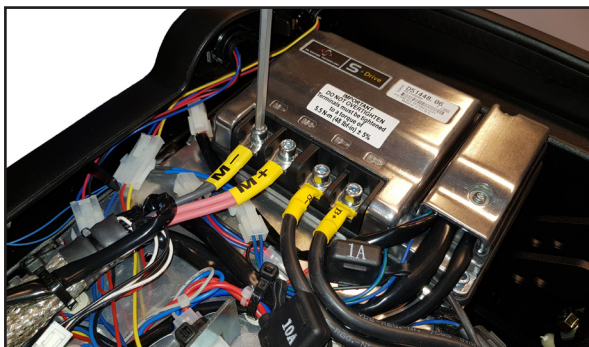
Electronics board for X1

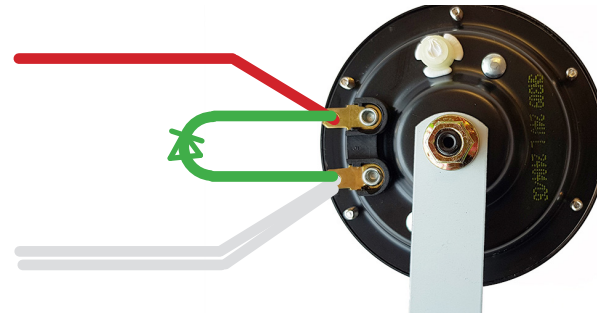
From Serial Number 03-52797-22-06 a diode was installed as shown above. It must be removed before the current diode is installed.

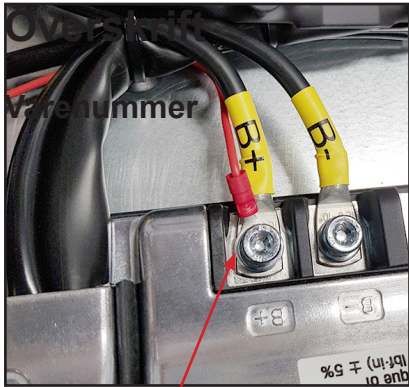
New diode - the cable lug on the diode set is mounted together with B+.

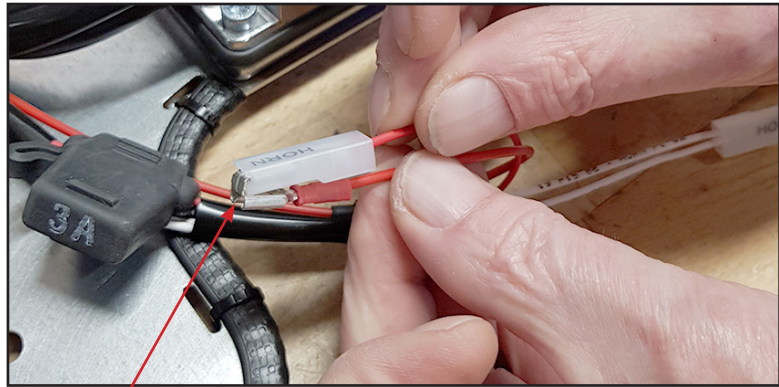
The connector at the other end is mounted on the red Horn cable from til Main cable. Clip in as shown.

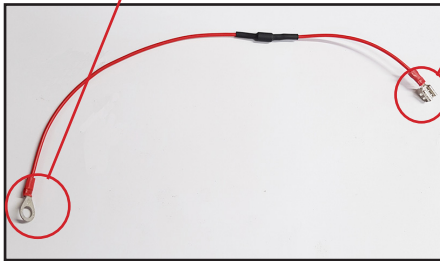
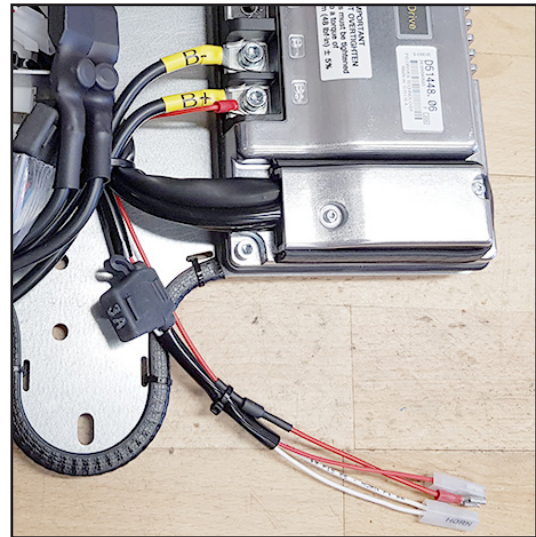
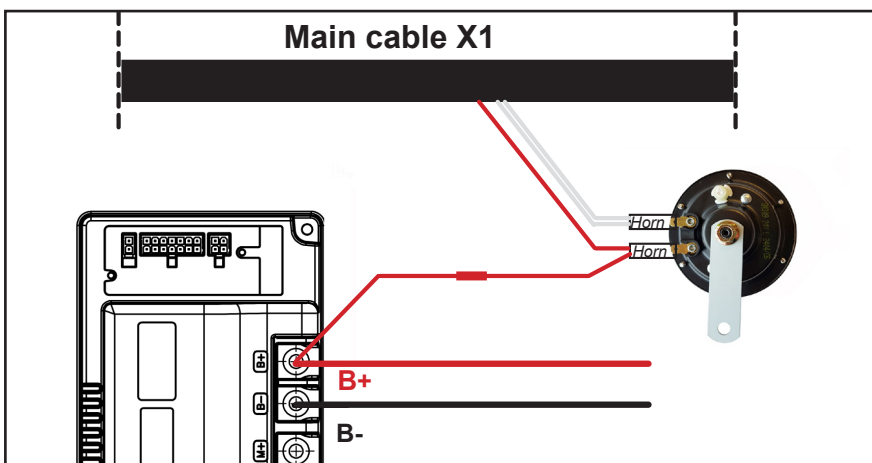
Diode for horn - X1 mounted.
